## FINAL REPORT

HIMCO SITE  
 ELKHART, INDIANA

Prepared for: Himco Site Trust

**Conestoga-Rovers & Associates**  
 651 Colby Drive  
 Waterloo, Ontario N2V 1C2  
 Canada

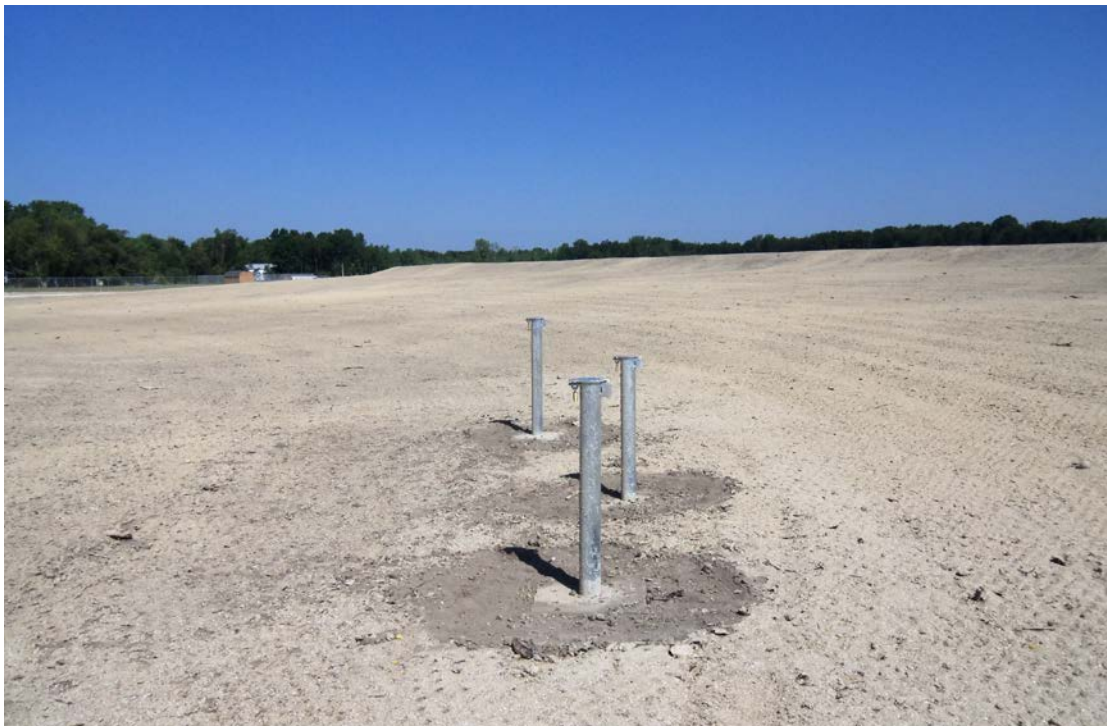
Photo 8: Monitoring Well Nest- WT115

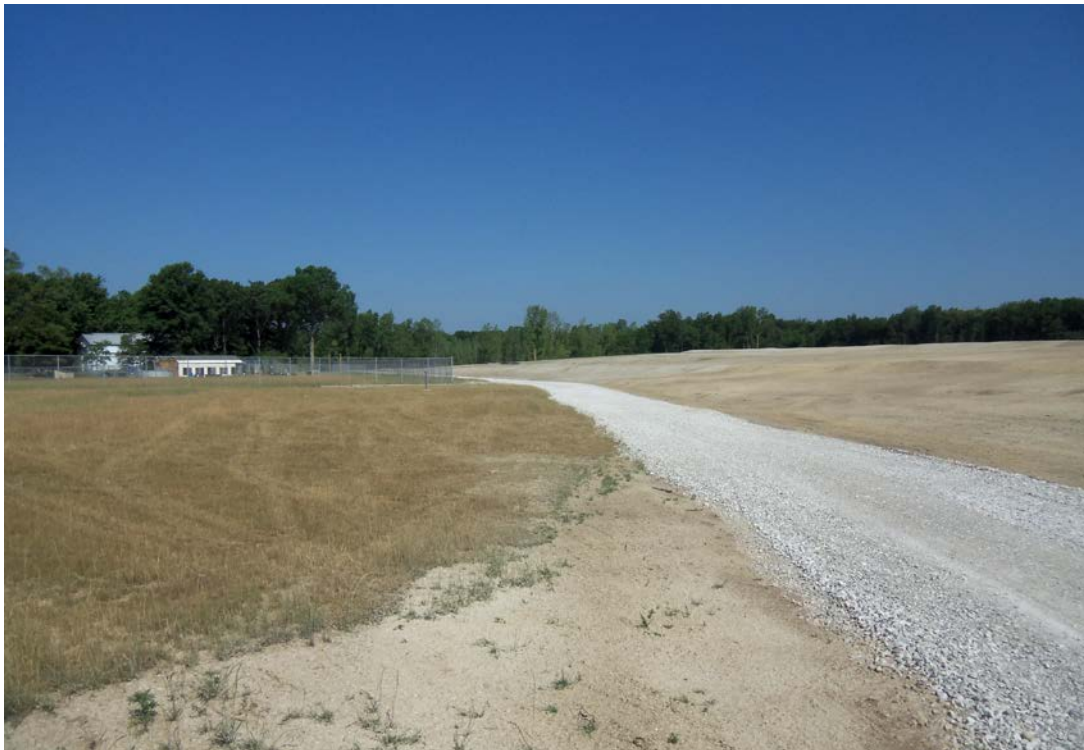
Photo 9: Final Cover and Access Road - 2012

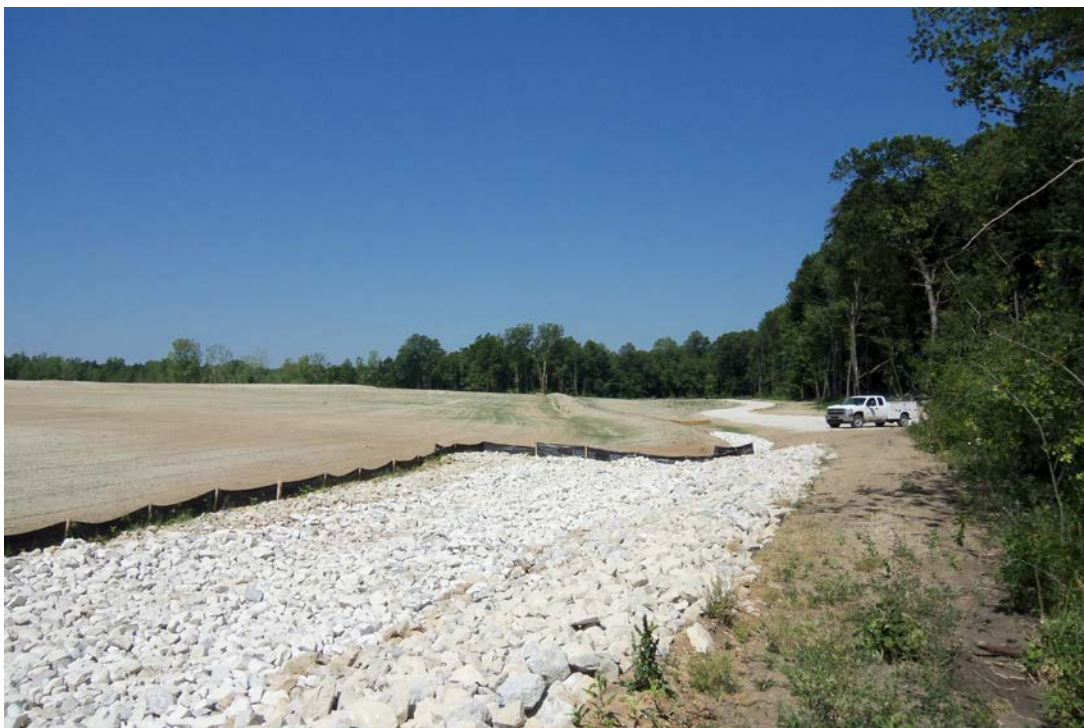
Photo 10: Rip Rap adjacent to Quarry Pond - 2012

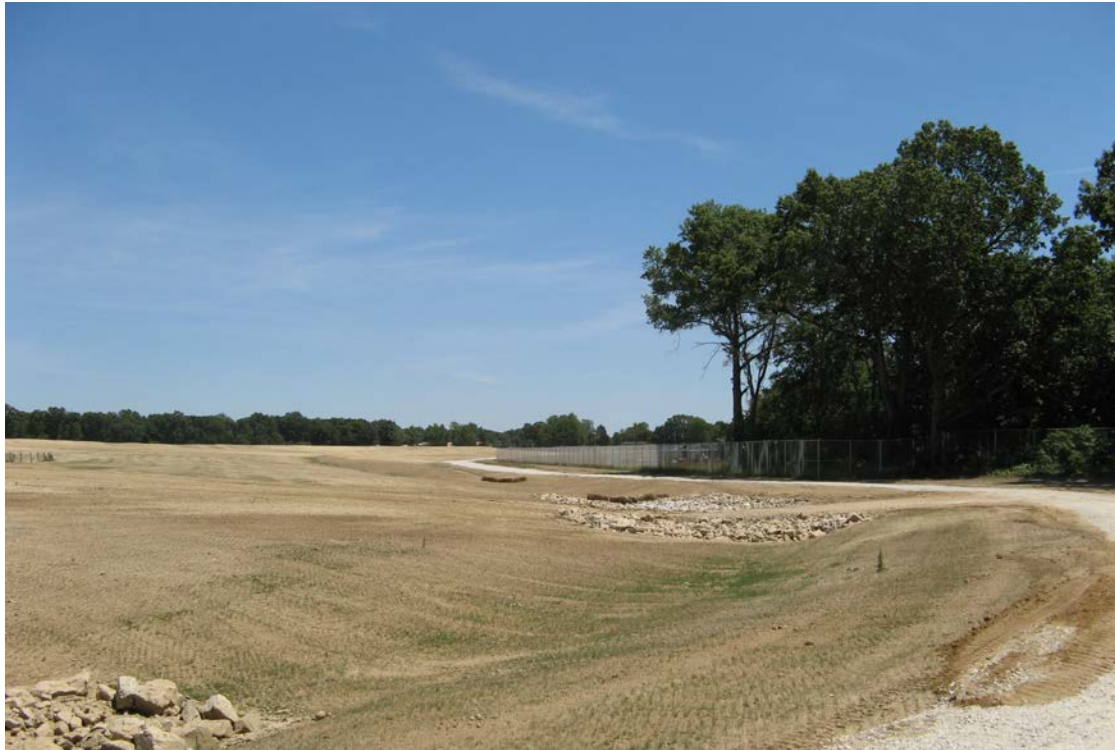
Photo 11: Stormwater Diversion Berm with Swale - 2012

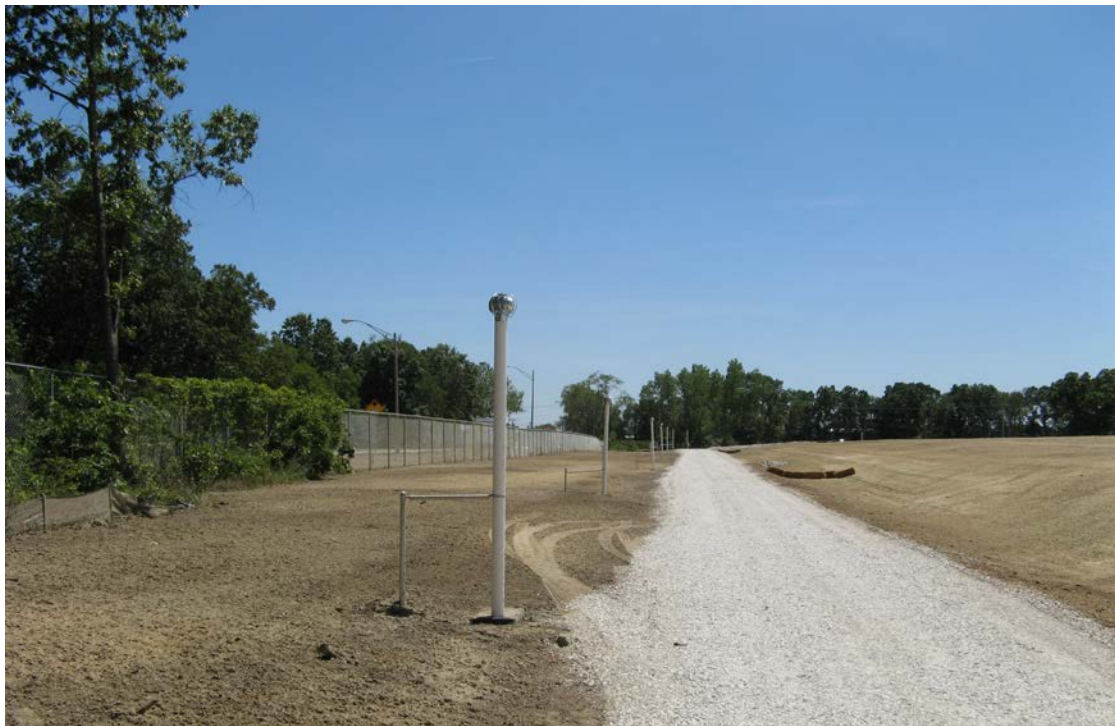
Photo 12: Passive Ventilation Trench - 2012
